ROCHESTER'S HISTORIC PARKLANDS

The City of Rochester

A SURVEY OF ROCHESTER'S HISTORIC PARKLANDS

BASIC SITE INFORMATION

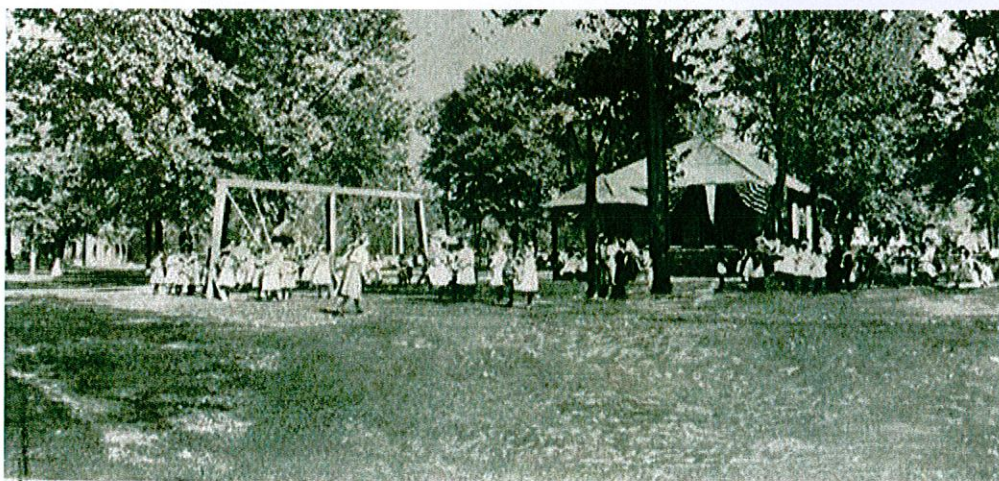
Advocates of the Reform Park movement in the 1890s and 1900s supported creation of supervised parks intended primarily for the structured instruction of children, and in 1903, Brown Square became the city's first official playground. New facilities added in 1903-06 included a brick and stone shelter, restrooms, a wading pool, skating rink, outdoor gymnasium, toboggan slide, and play apparatus. As part of the transformation of Brown Square into a Reform Park, the Olmsted Brothers created an elaborate plan to incorporate these new features; due to concerns about the expense of carrying out the original plan, the design was revised and somewhat simplified, yet this design was not carried out, either. In a September 1904 site visit, J. C. Olmsted noted that "practically nothing" had been done except to erect a small shelter for children, and even that "looks bad."

Brown Square playground, 1903

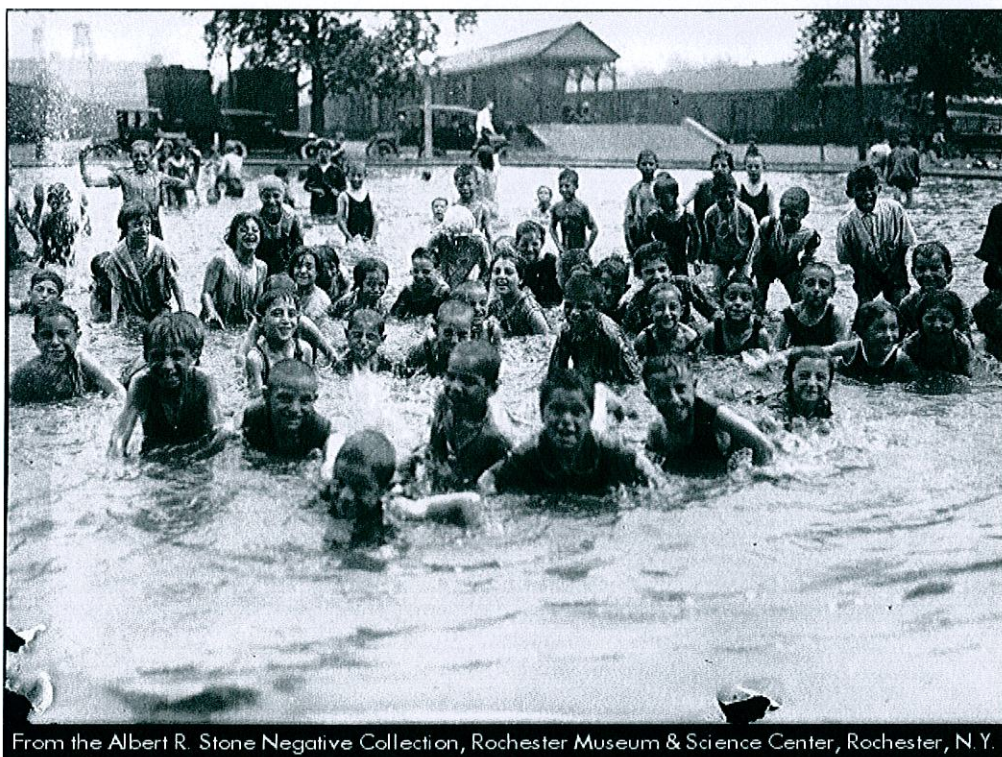
A wading pool was introduced the site in 1905 and was widely used, representing an important part of the park's Reform Park/playground significance. The wading pool was removed at some point after 1963. No traces of this structure currently exist. The existing raised planter, curved seating walls, and flagstone path are now in the former location of the wading pool.

Brown Square Park, wading pool. (Albert Stone Collection, courtesy RMSC)
